DIAGNOSING AND CORRECTING ASSEMBLY PROBLEMS

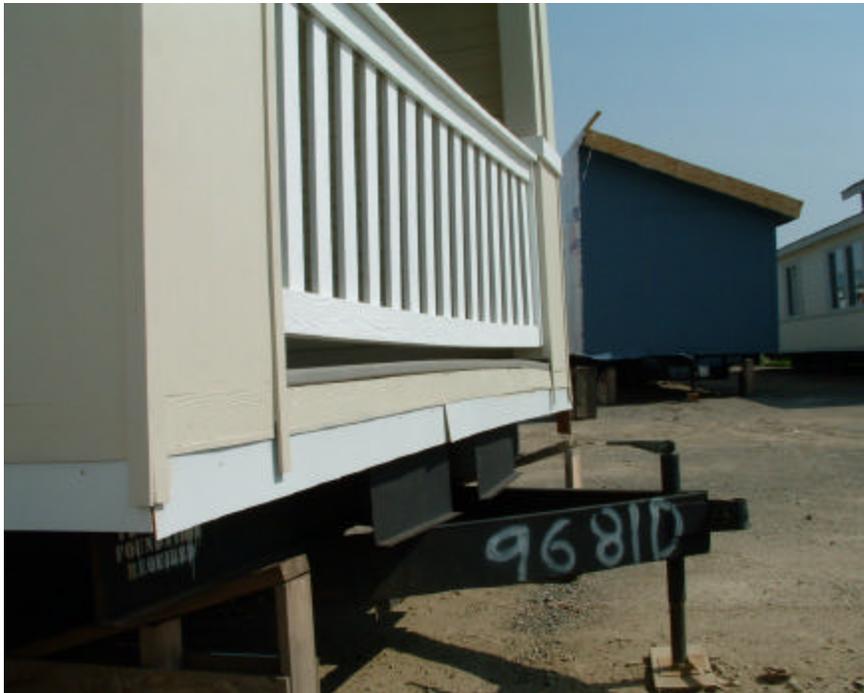
Floor crown

This photo shows floor crown that can happen when the weight of a roof structure and sidewalls bears down on the perimeter of a typical transverse floor joist structure. The joists are effectively cantilevered about 30" from the chassis support rails and bend accordingly. This effect will run all along the length of the home sections and be pronounced at ridge support posts. This condition will be framed or blocked into an installation if corrective measures are not taken. The home must be correctly supported along the perimeter and marriage (roof support) at one correct bottom of floor elevation and the chassis (floor support) must be at an elevation equal to the bottom of floor elevation less the height value of the chassis. When a home with floor crown is leveled this way, the chassis will often rest free above the chassis piers for some time as it relaxes. A final pier tightening may be necessary after an adequate relaxing period.

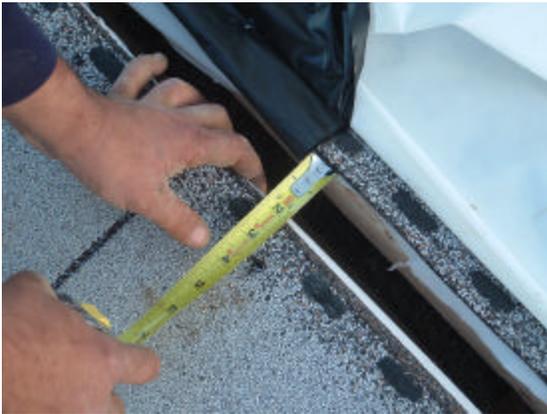
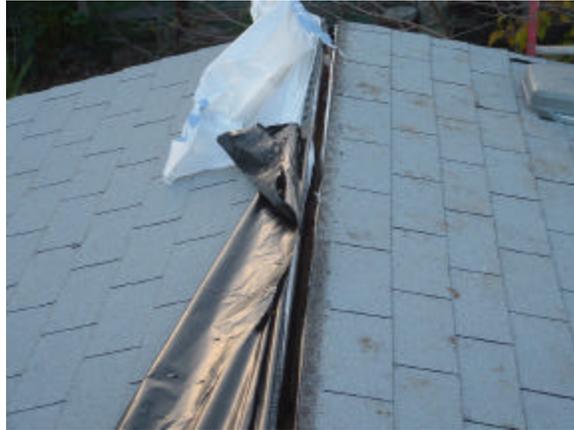
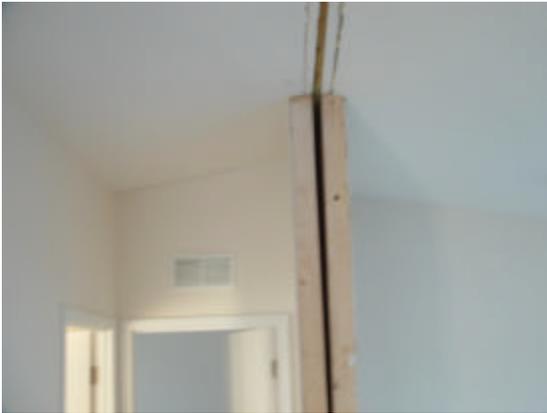
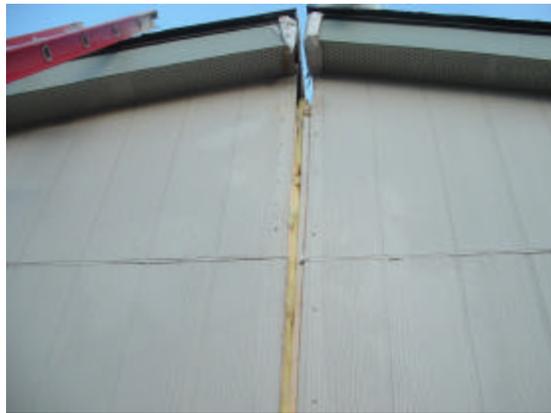
Floor crown affecting roof closure

With the chassis piers installed to their correct elevation and the sidewalls not yet properly leveled to bottom of floor elevation, this home has a substantial gap at the roof. Since this home sat in storage during the damp winter, the floor crowned as roof structure weight bent the floor joists where they cantilever over the chassis. The sagging sidewalls pull the roof apart to some extent and must be properly leveled before shimming and bolting the roof. If corrections are not first made to the sidewall elevations, the home will be framed or blocked in a deformed manner with sidewalls sagging about 1/2". Properly support the sidewall to correct elevation and the gap will diminish partially, then shim and bolt in accordance with manufacturer's installations.

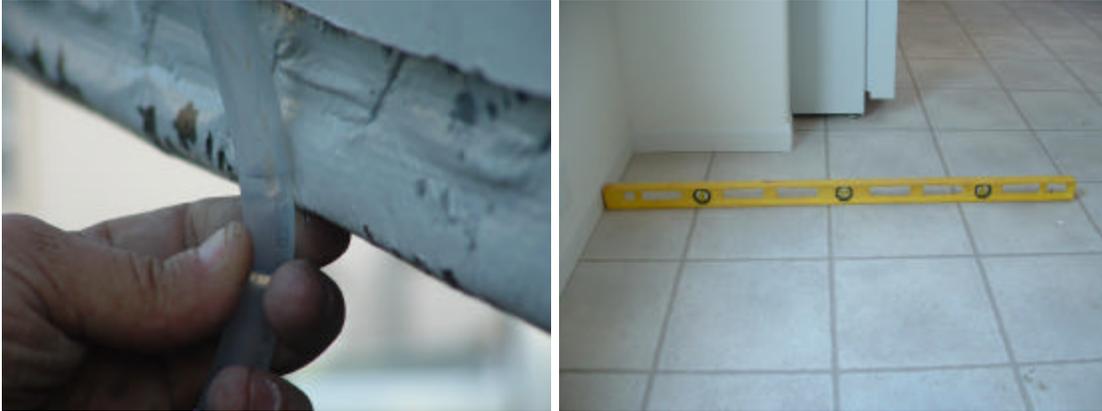
The water level set to bottom of floor elevation (equal to chassis elevation + chassis height) confirms that the sidewall is sagging since the chassis piers are set to chassis elevation.

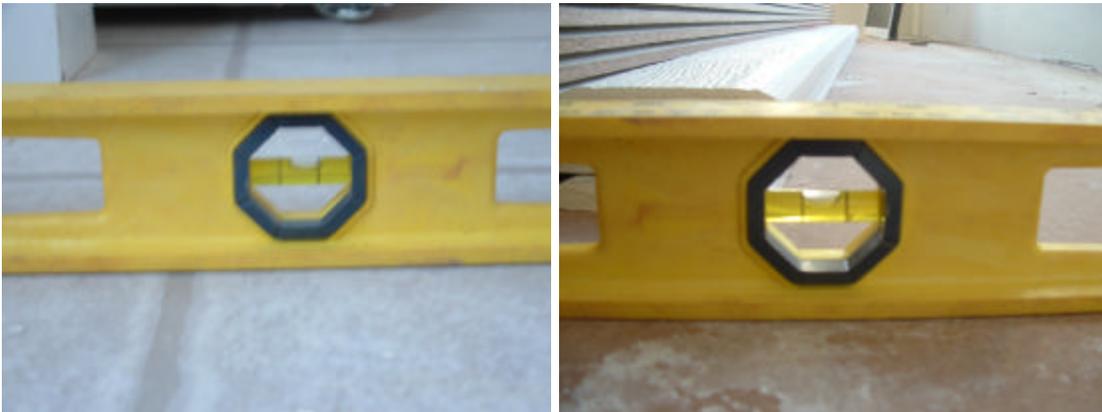
A carpenter's level at the sidewalls confirms the sagging sidewalls at about 2% slope or about 1/2" from the chassis to the sidewall.

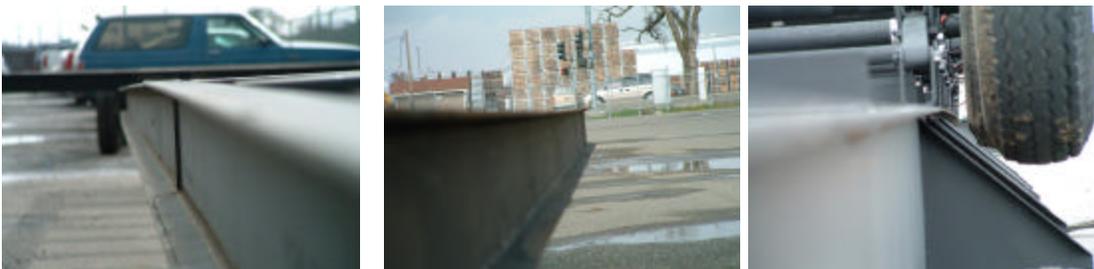
Note the camber built into this chassis. While there is a joint in the beam, the bend is designed to provide spring support to the home structure until it is supported on a foundation.

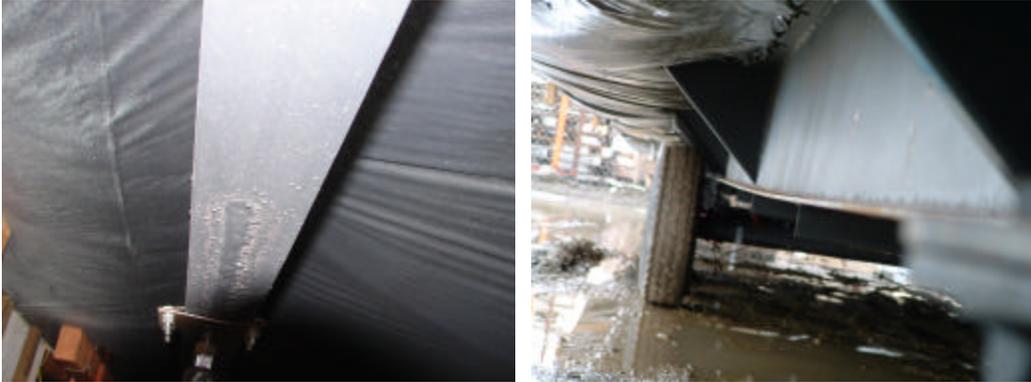
Here a bead of weld is set between the axles and hitch to camber the chassis up here and resist sagging. The chassis on the right needed more or has been stored unsupported too long.

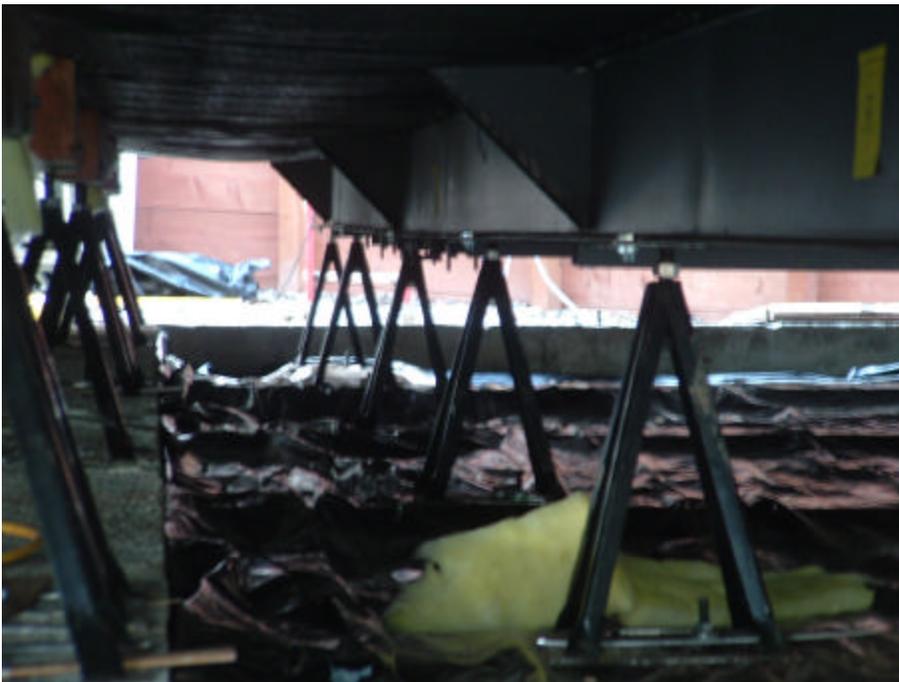
This chassis is over cambered at the axles so the bent chassis is resting above correct elevation. The weight of the home and roof may help this home settle some, however if it is too much it may need to be relief cut or weld beads added to the bottom of the apex to straighten the bend. I prefer to leave the chassis piers at correct elevation for a week or two if time permits and let the home relax if it will. If it will not and is tolerable to the occupants, the chassis piers and perimeter framing should be raised to the chassis and bottom of floor as needed and it will remain cambered a tolerable amount.

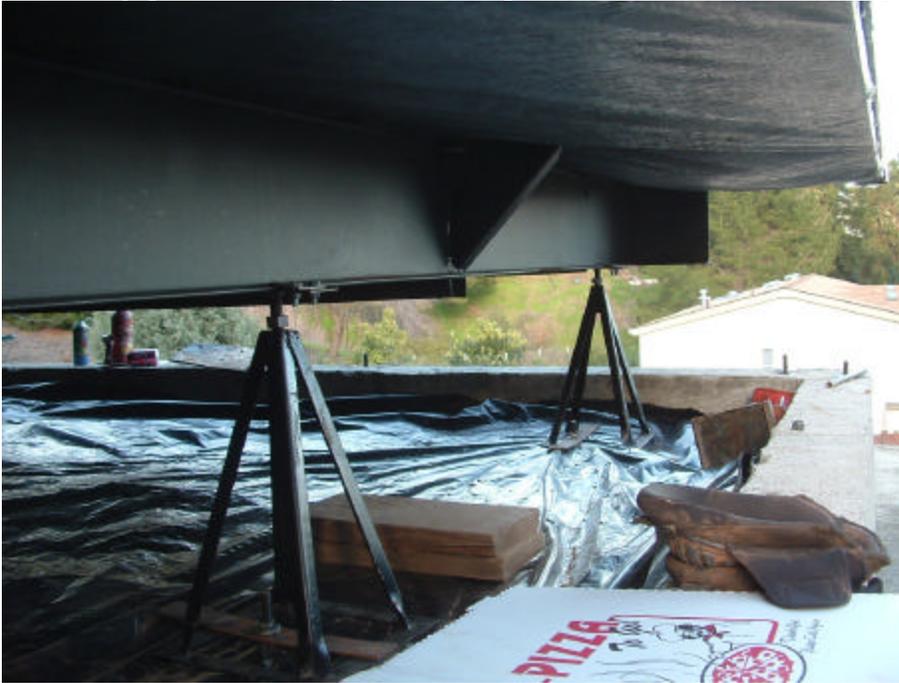
Note the gap between the piers and the pier nuts. This may settle out partially.

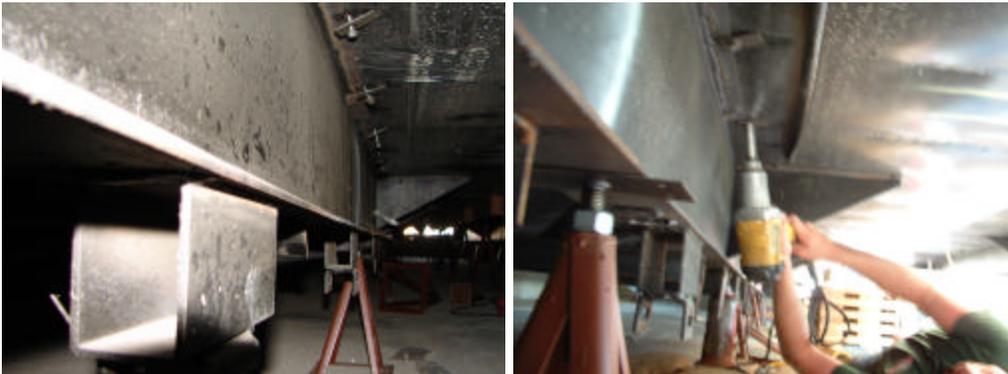
This home had so much chassis camber, the rear end wall was 2 1/2" above grade. To correct the problem, the chassis was lowered so the perimeter wall and marriage piers were the only remaining support. This rail was then unbolted, lowered, cut to relax, straightened and re welded, then the chassis was restored to proper elevation, fastened and blocked. This is an extreme case but it needed extreme measures to allow the home to be assembled.

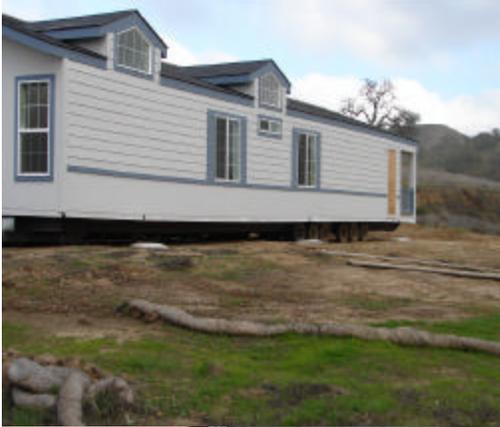
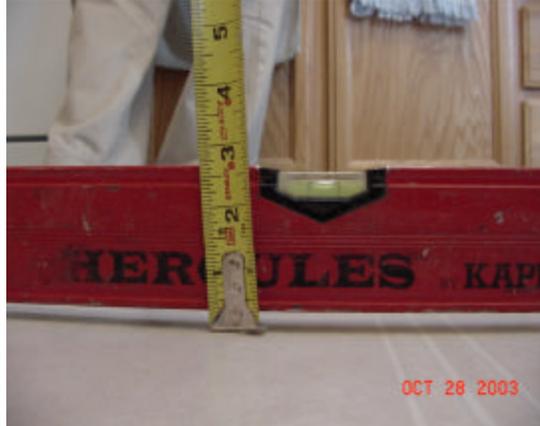
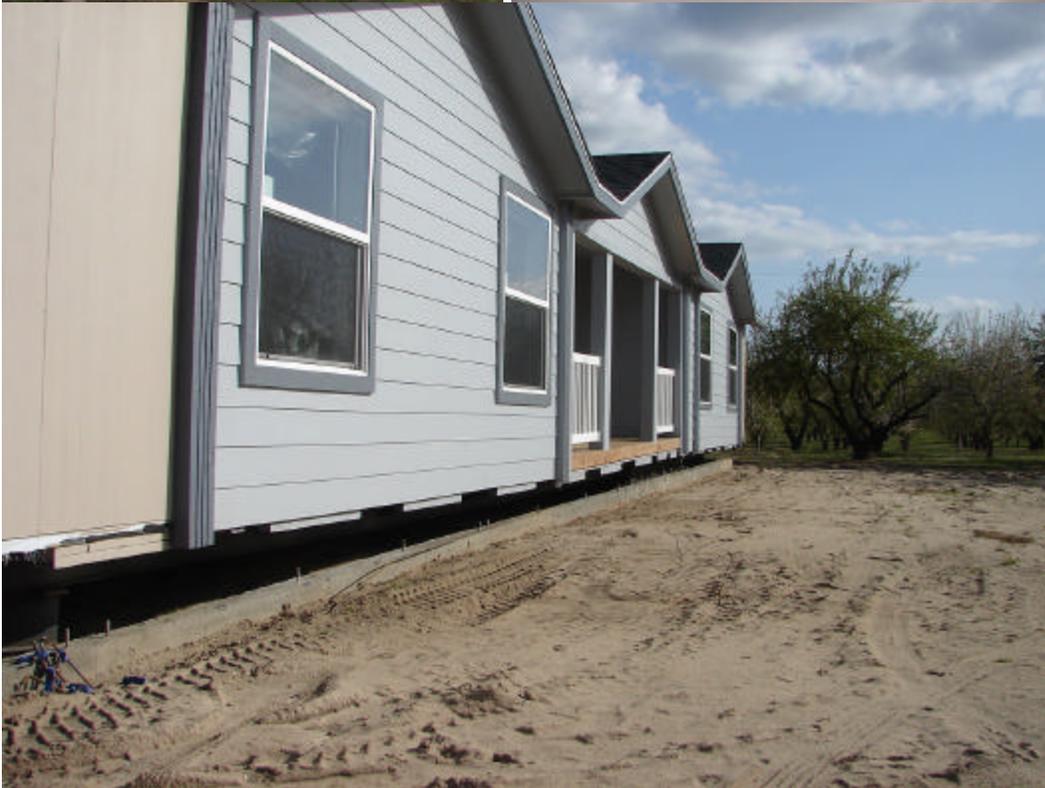
This home has been sitting for a year and the chassis camber has lost its spring and relaxed. The sag will jack out, but the sheetrock is likely cracked, mildewed, and the floors crowned badly from sitting unsupported. It is also common for rain water to run down the plastic close-up and into the under-floor rodent barrier where the extreme humidity can buckle the floor decking and push partition walls, doors and cabinets out of level. I usually insist that the home is not ordered until the permits are issued and the foundation footings are dug. Having a home sit in storage too long is a bad practice. If I get a call to install a storage rat like this I will pass on it. There is no way to have a satisfied customer with a messed up home and the installer will likely have to defend his installation work when the complaints come.

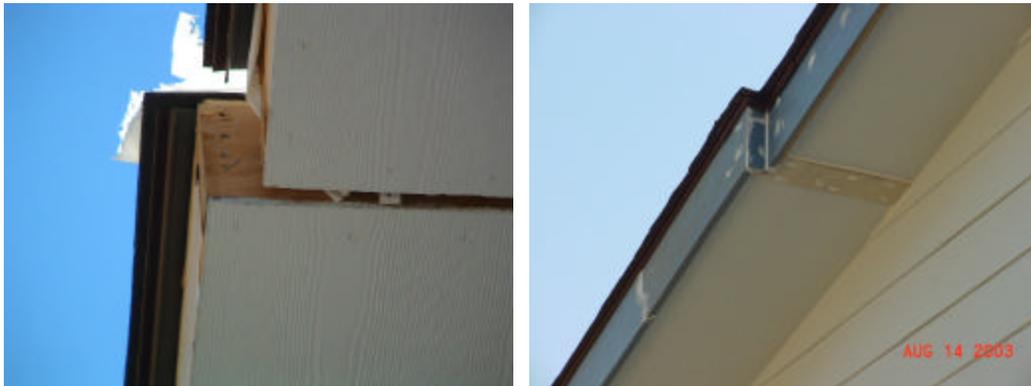
This mismatch was trimmed and sealed up to prevent damage until the factory service could arrive and correct the eave.

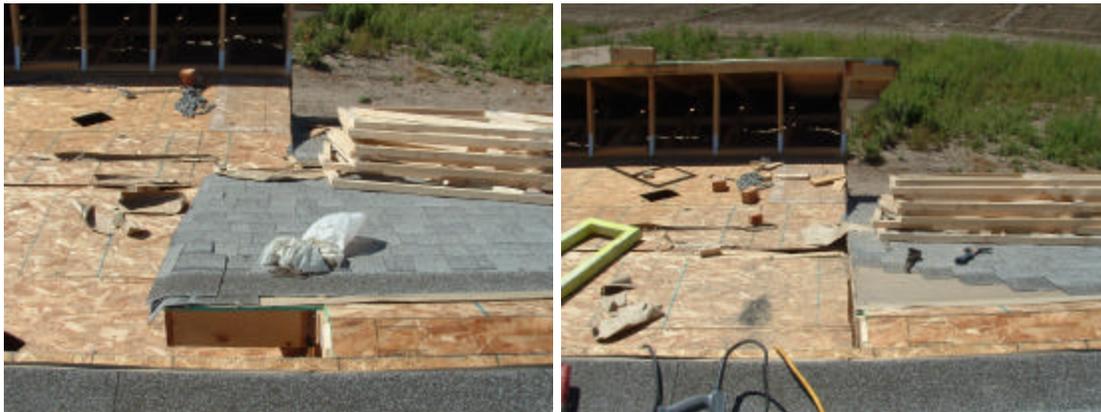
Here an eave was built where trusses should be placed on this truss on site center section; it had to be cut off.

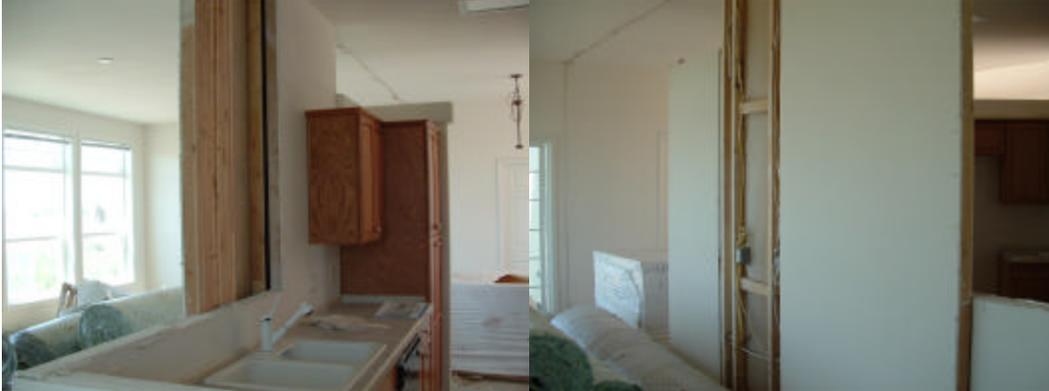
This matting line wall was misaligned significantly. One problem is the tie down straps from the floor through the wall posts to the ridge beam that must remain intact.

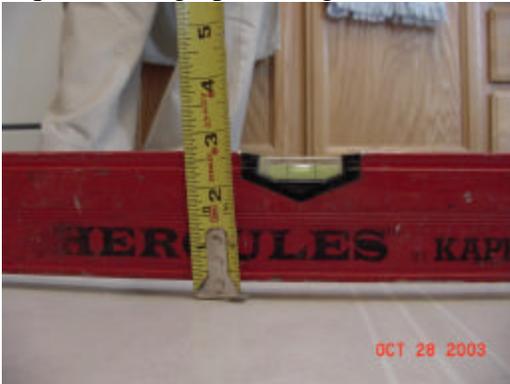
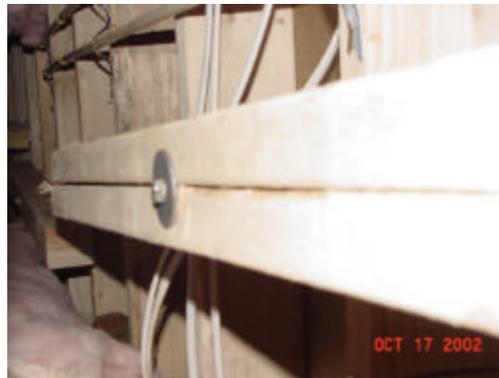
Here is a bowed floor joist from a wood joist system. Often the floor joists will bow between spans, especially if they absorbed moisture from under the home causing the deck to bow and bend a floor joist. This is not because of pier supports being out of level. Floor joists can be corrected by using a strong back brace(a length of lumber running along the floor line between the chassis rails and bolted to each in an attempt to tie them to a common elevation), an approved cut and sister joist splice or replacement, which requires taking up decking.

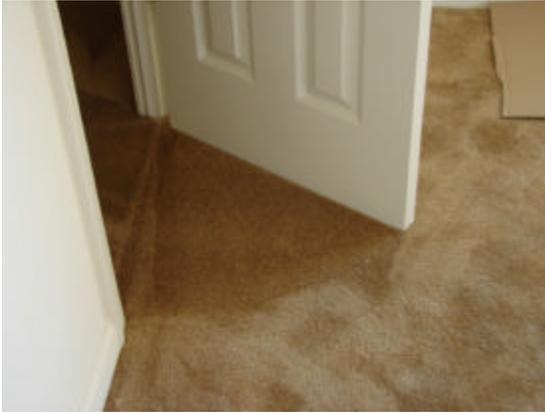
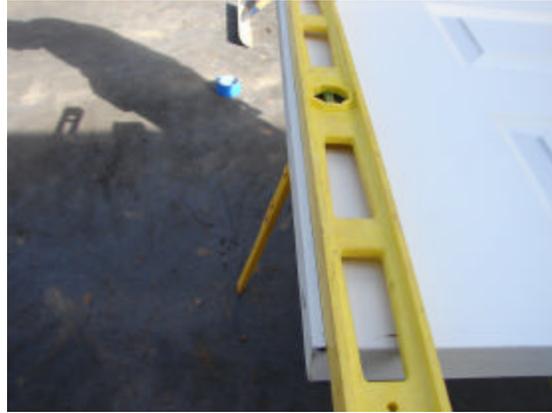
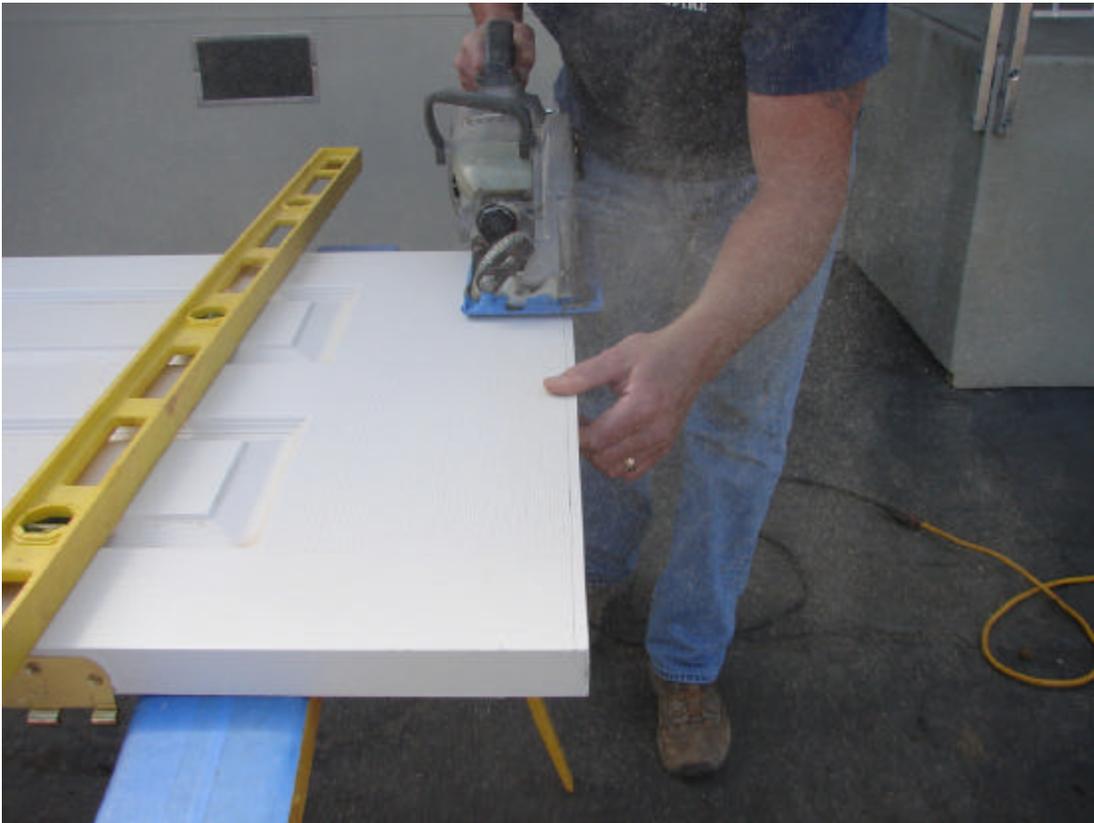
A combination of thick carpet and pad will often cause doors to drag the carpet. The simple time tested solution is to pop the door hinge pins, draw a straight line and trim the door. Generally 1/4" to 3/8" is about right. The saw should be used in the direction that allows it to be fully supported by the door. Drive the saw slowly and accurately for a straight splinter free line. If the doors are out of square or need a re hang adjustment, do that also. Take care to protect the door from dirty hands and damage. This saw and saw horses had masking tape applied to their surfaces.
