DIAGNOSING AND CORRECTING ASSEMBLY PROBLEMS

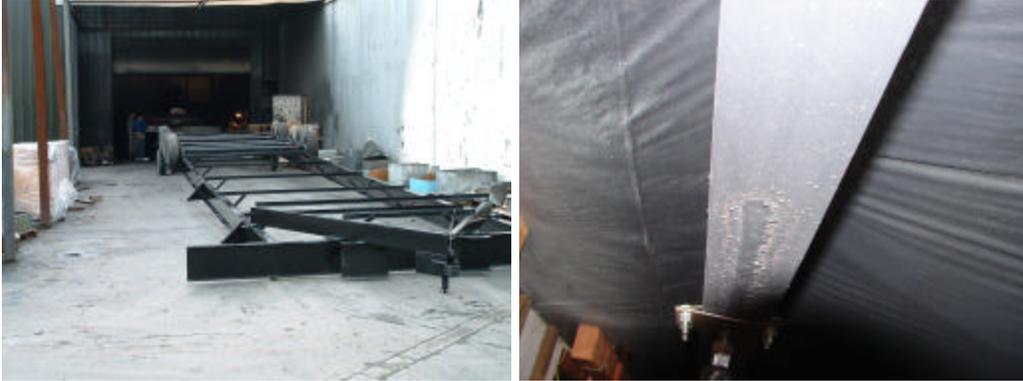
Here is a standard I beam chassis for a transverse wood floor joist system. The factory builds them upside down, bends them with beads of weld to create spring support and then attaches the home floor system to them.

The chassis builder applies beads of weld to the chassis on top of the chassis between the axles and the rear end which bends the frame up to support the tail end load. They apply beads to the bottom of the chassis between the axles and the hitch end to cause the frame to arch up in that area to support the load. It takes some experience and guess work to have this come out acceptably. It cannot always be exact or correct since it depends on how long the unit is stored unsupported, how far it is shipped and how many bad bumps it takes in transit. At times, there is too much camber or arch and the unit may remain uneven in elevation during and after installation. If it is too bad to leave as is, it can be corrected with welding beads opposite the excessive bend or cut and spliced. Usually occupants do not complain of minor elevation issues caused by excessive camber.

Note the camber built into this chassis. While there is a joint in the beam, the bend is designed to provide spring support to the home structure until it is supported on a foundation.
